Manhole Inspection Summary

Manhole # S25E__055MH

Insp Date: **8/7/07 9:48 AM**

Location Address: **1120 CARLTON ST**

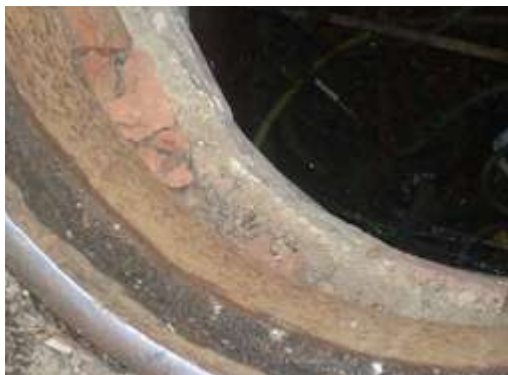
Defect 4

Frame Offset: **4** (in.) Condition: ☒ Sound ☐ Cracked ☐ Leaks

FRAME OFFSET

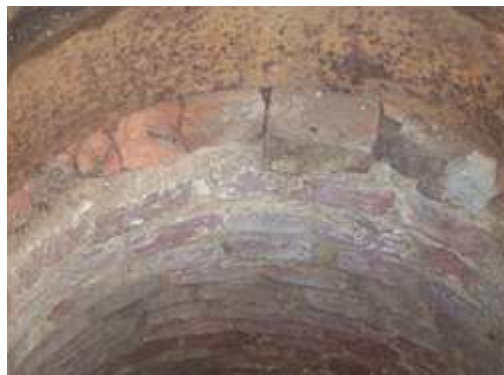
Defect 3

Chimney / Frame Adjustment ☒ Exists Material: **Brick** ☐ Parged Height: **3** (in.)

Condition: ☐ Sound ☐ Cracked ☐ Root Intrusion ☐ Loose Brick ☒ **Deteriorated**

DETERIORATION OF CHIMNEY

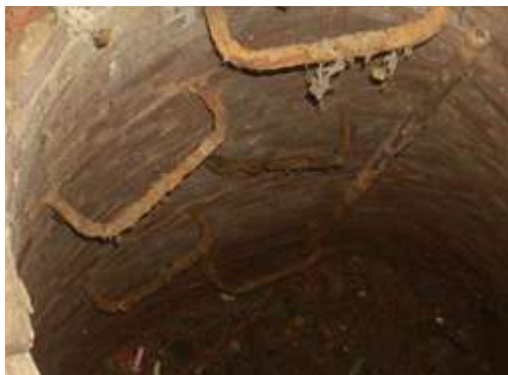
Defect 2

Steps Count: **4** Missing: **1** ☒ **Corroded**

MISSING AND CORRODED STEPS

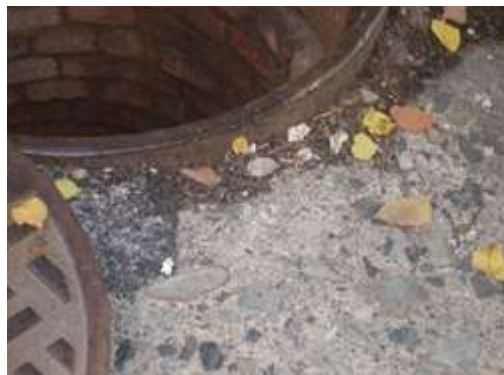
Defect 1

Cover Shape: **Circular** Diameter: **24** (in.) Length: (in.) Dist A/B Grade: **1** (in.)

GRADE ADJUSTMENT

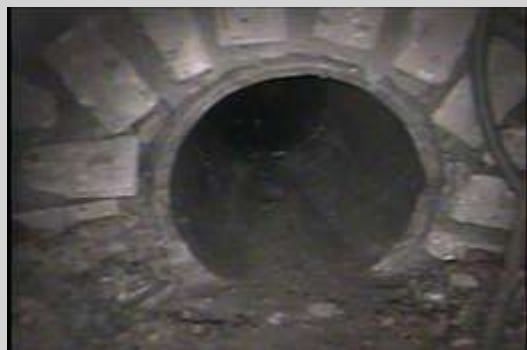
12 O'Clock Outflow

8 in. Circular Gravity Sewer
Pipe Out @ 12 O'Clock

Infiltration: **None** Pipe Seal Cond: **Sound**
